Reduction of Power Output from Undersized Inverters

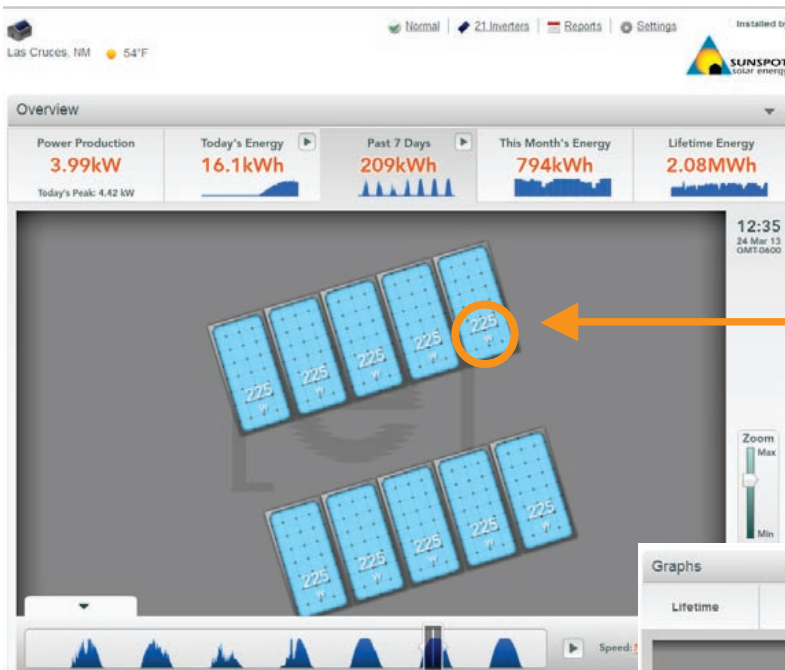
Output for these modules shows 225 W, which is the maximum output for the Enphase m215 microinverter. The output of these modules is clipped because the inverter maximum output is only 88% of the module rated output (255 W). This is a poor combination of equipment.

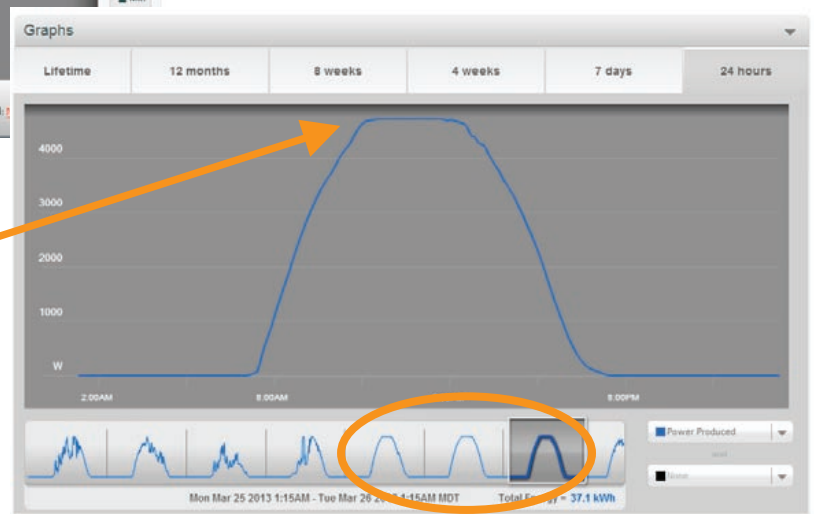
The top of this curve is flat, indicating that power clipping is occurring. With properly matched equipment, this should look like a normal bell shaped curve.

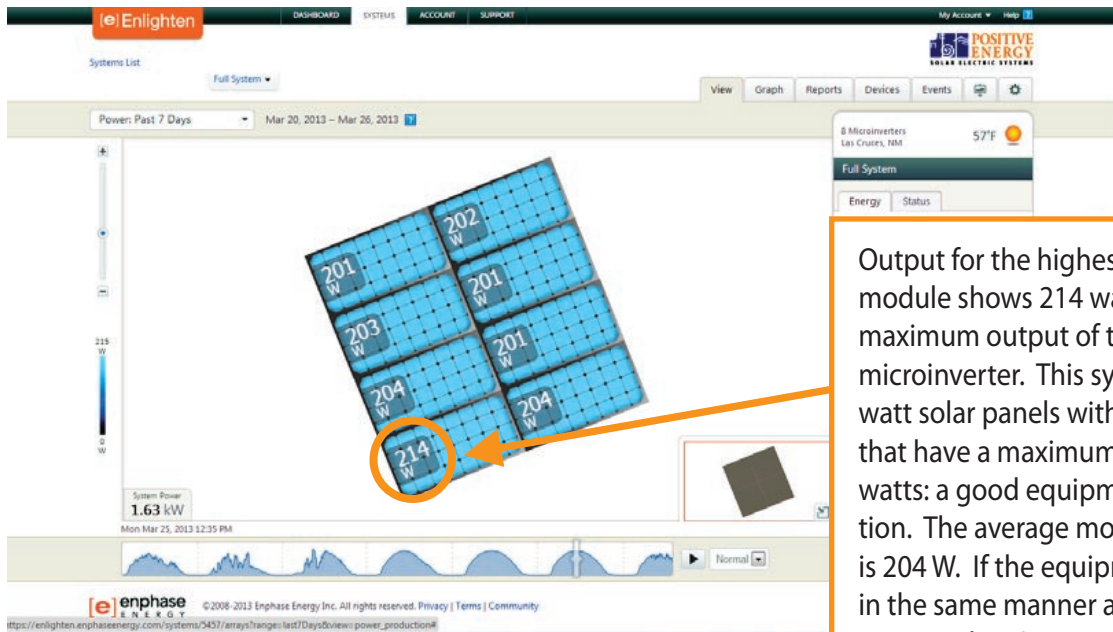
Output for the highest performing module shows 214 watts, under the maximum output of the Enphase m210 microinverter. This system pairs 215 watt solar panels with microinverters that have a maximum output of 219 watts: a good equipment combination. The average module output here is 204 W. If the equipment were sized in the same manner as the equipment in Example 1 (inverter capacity = 88% of module capacity), then each module would have been clipped at 189 W.

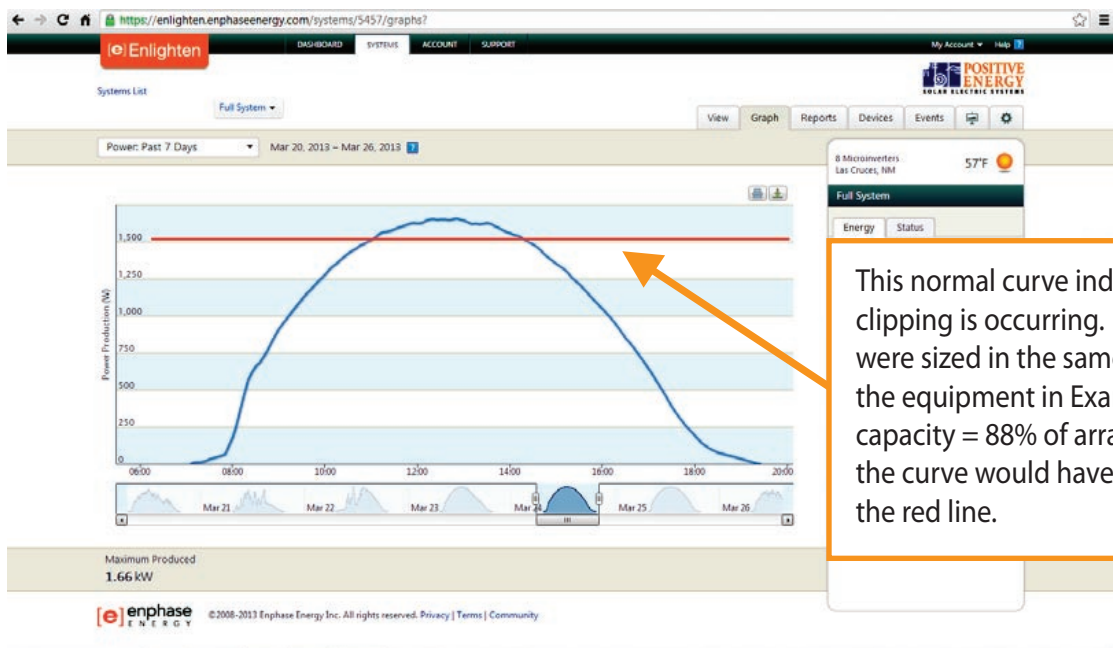
This normal curve indicates that no clipping is occurring. If the equipment were sized in the same manner as the equipment in Example 1 (inverter capacity = 88% of array capacity), then the curve would have been clipped at the red line.
